Steel Mill High Pressure Hydraulics

Hydraulic Oscillator System Element Upgrade

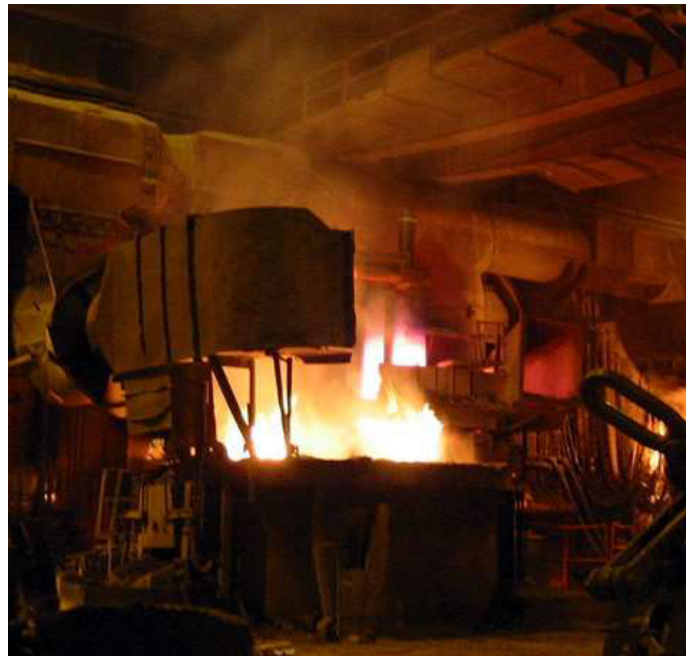
The hydraulic oscillator delivering molten steel into casting molds in this application was operating at a sub-standard level. The hydraulic system, which oscillated the pour of steel from an electric arc furnace into the molds, consisted of 250cc pumps driving a large servo valve which oscillated the pouring steel 6mm per stroke. Frequent filter replacements and hydraulic fouling lead to the assumption that improving fluid cleanliness would improve reliability. It was predicted that upgrading from the original elements to Donaldson Hy-Pro elements would be a solution. Elements were located at pump discharge, servo pilot pressure filter, offline loop, and return line.
