Steel Mill Gear Lubricating Oil

FSL Install for Gear Lube Cleanliness Upgrade

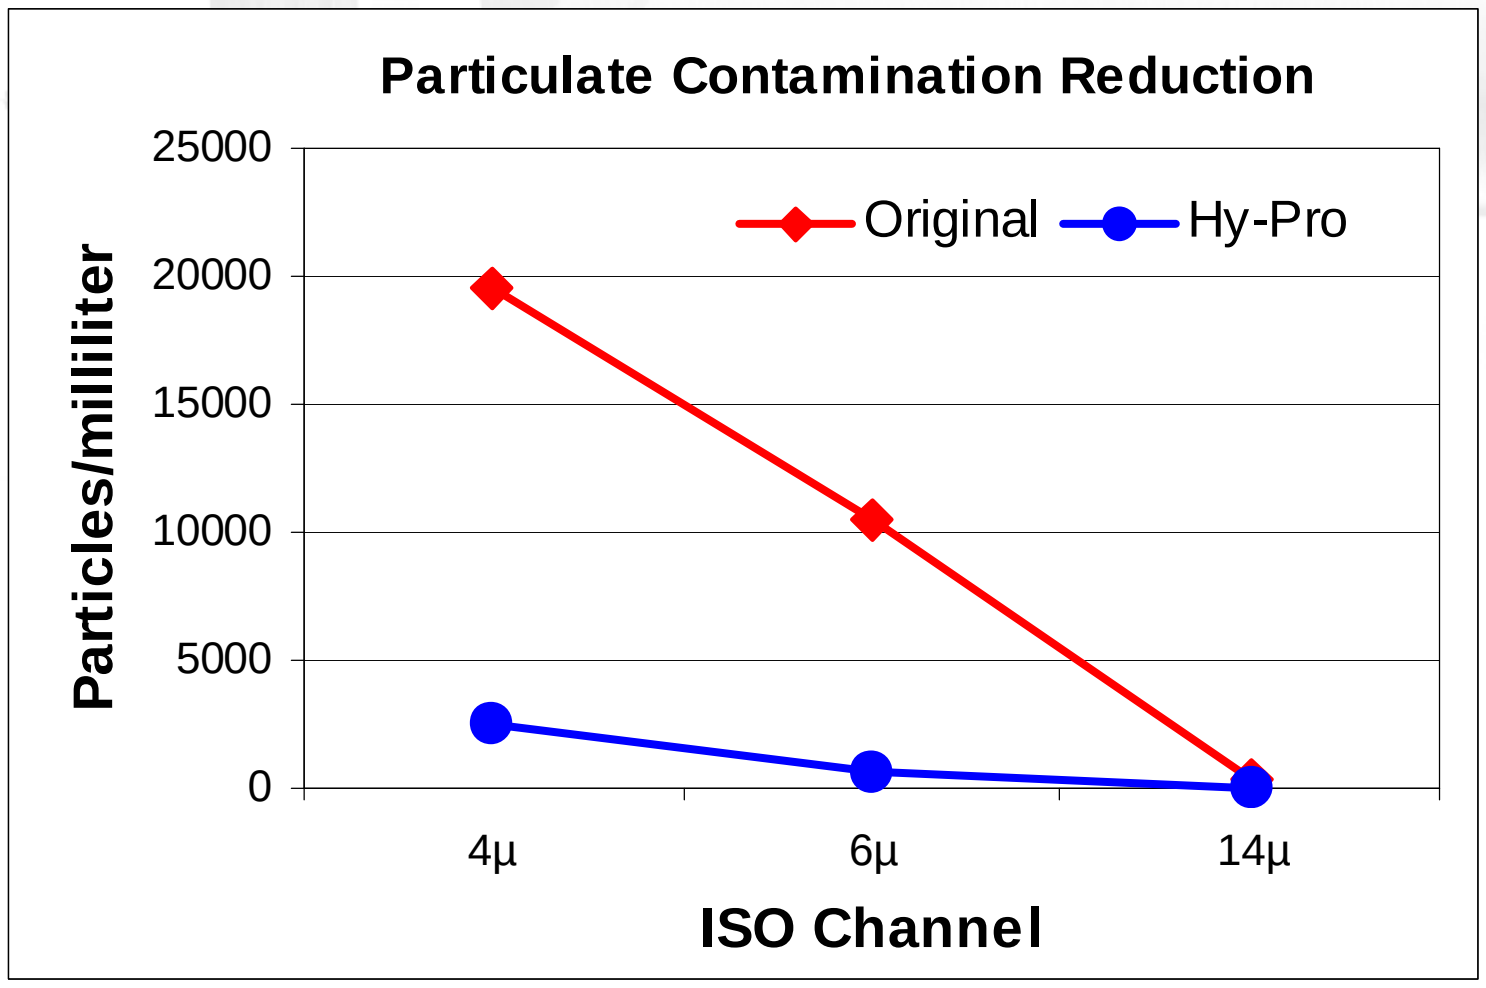
The Results - The primary goal was to extend useful oil life and extend gear and bearing life. After the Hy-Pro FSL system was installed the ISO cleanliness codes were lowered to long-term acceptable levels. On-line particle counting was used to quantify the fluid cleanliness after the Hy-Pro upgrade. The Hy-Pro elements yielded substantial improvement in ISO fluid cleanliness codes visible in the tables and graph below. With the Hy-Pro elements there was a **87.5% reduction in particles $4\mu_{[c]}$ and larger, a 94.3% reduction in particles $6\mu_{[c]}$ and larger and a 90.1% reduction in particles $14\mu_{[c]}$ and larger**. Water contamination is a common problem in Morgoil and gear lubricating systems. Ask us about vacuum dehydration solutions to control both water & particulate. **Stop decanting** water and putting oil down the drain, and **extend oil life**.

Original Elements	$4\mu_{[c]}$	$6\mu_{[c]}$	$14\mu_{[c]}$
ISO Code (per 4406:1999)	21	21	15
Actual Particles per Milliliter	19,510	10,414	243

Hy-Pro Upgrade	$4\mu_{[c]}$	$6\mu_{[c]}$	$14\mu_{[c]}$
ISO Code (per 4406:1999)	18	16	12
Actual Particles per Milliliter	2427	593	24

Filter Element Upgrade - The system originally had 74 micron wire strainer filters placed on the return line. A Hy-Pro FSL3-L36-3MB was installed to filter the gear oil (Mobil MGEAR 634) as it was drained from the rolling mill and was re-circulated into the reservoir (~6000 gal) at the opposite side.

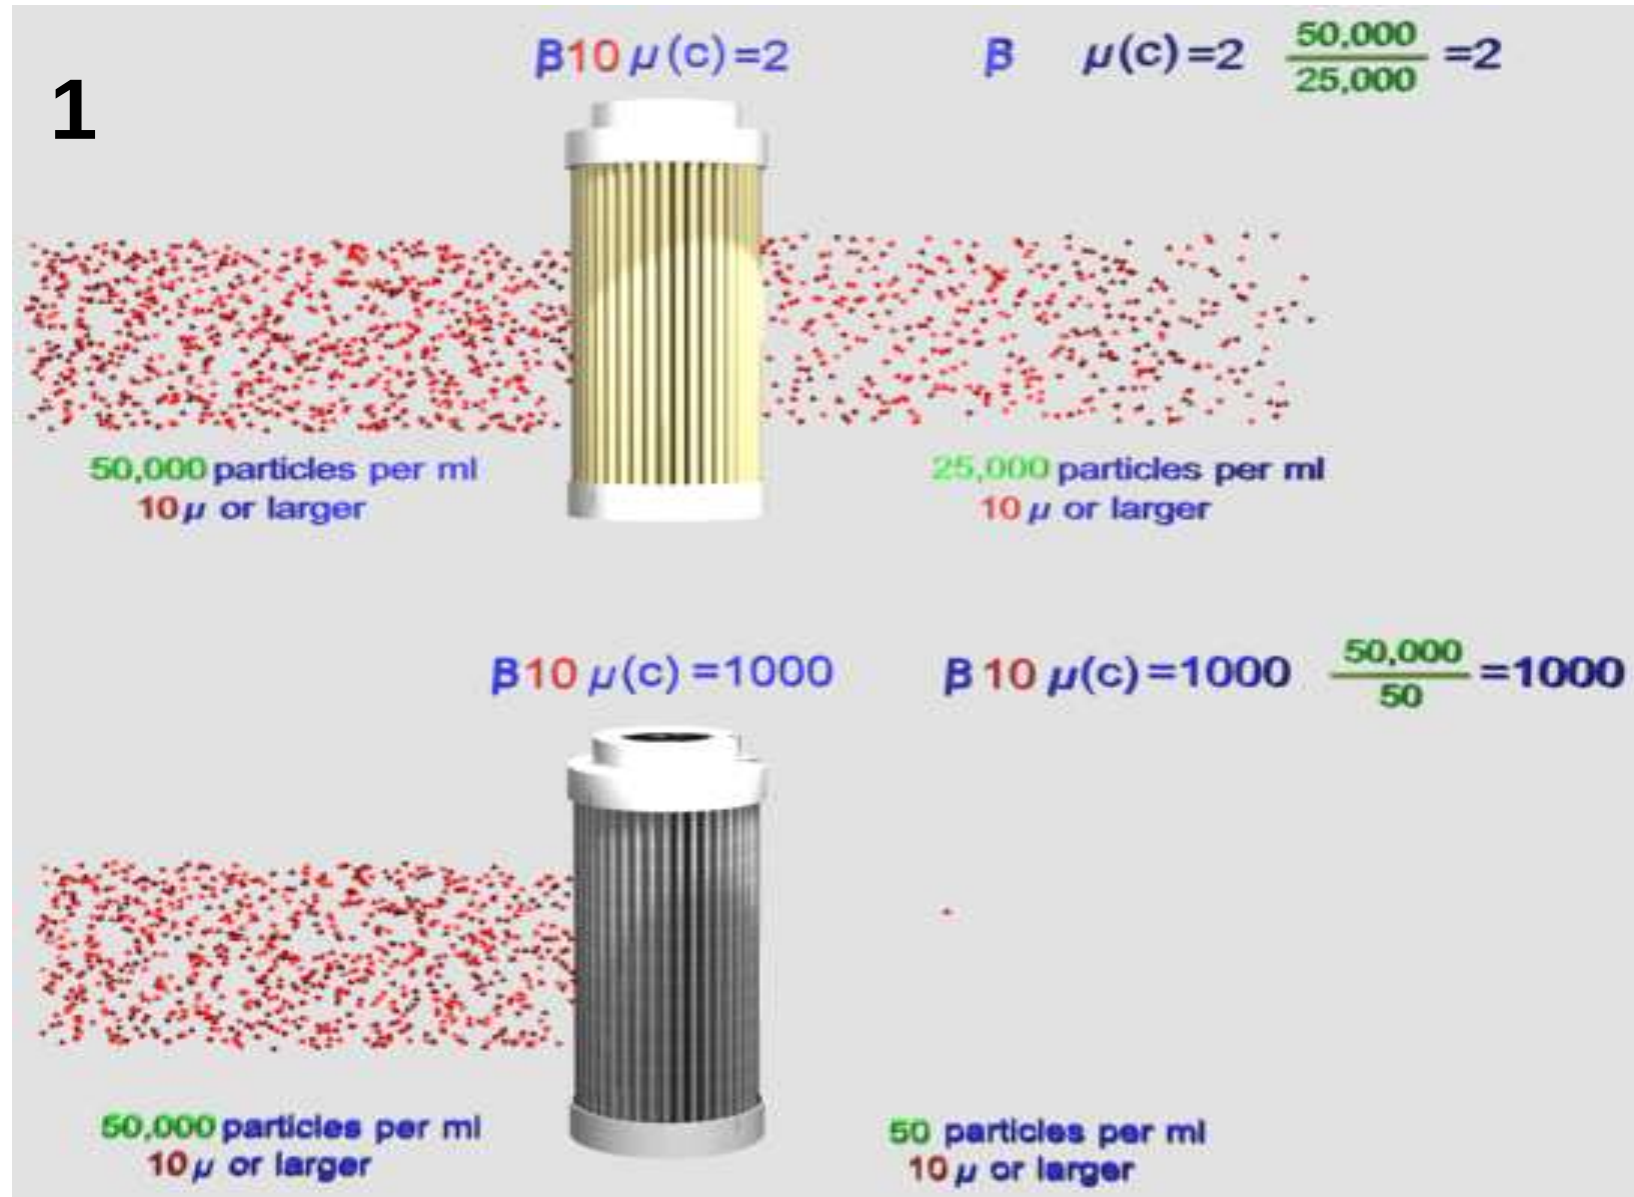
Elements of different media with the same “micron rating” can have substantially different filtration efficiency. Figure 1 provides a visual representation of the difference between absolute and nominal filter efficiency.

The illustrated glass element would typically deliver an ISO Fluid Cleanliness Code of 18/15/8 to 15/13/9 or better depending upon the system conditions and ingression rate. The cellulose element would typically achieve a code no better than 22/20/17.

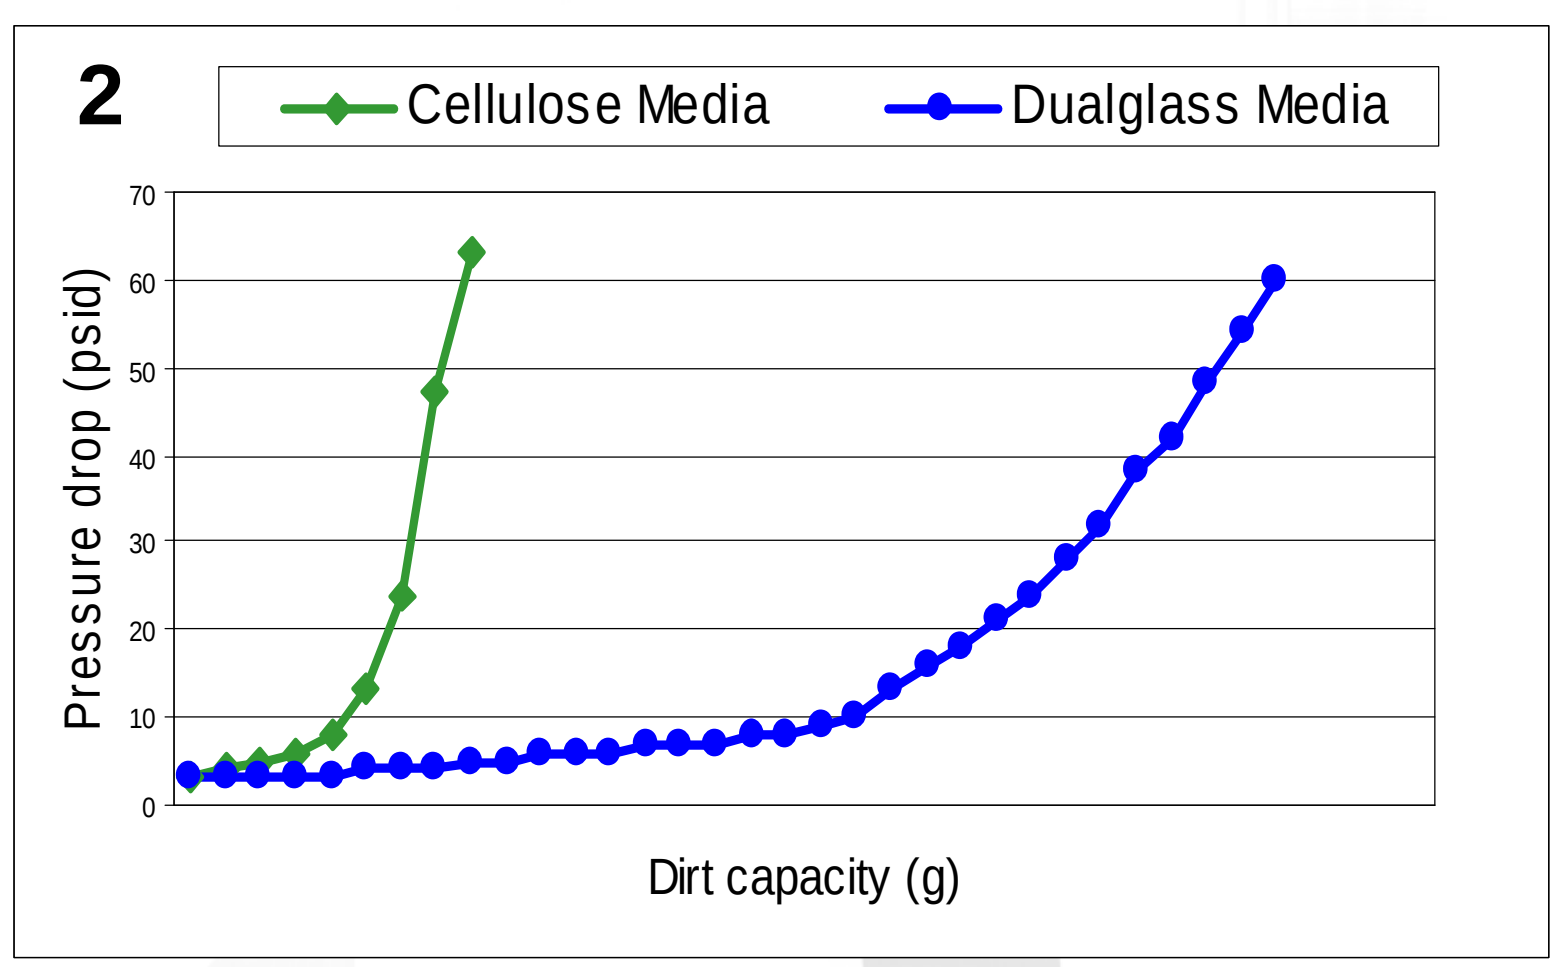
Glass media has much better dirt holding capacity than cellulose. When upgrading to an absolute efficiency glass media element the system cleanliness must be stabilized. During this clean-up period the glass element halts the runaway contamination as the ISO cleanliness codes are brought into the target cleanliness range. As the glass element removes years of accumulated fine particles the element life might be temporarily short.

Once the system is clean the glass element can last up to 4~5 times longer than the cellulose element that was upgraded as shown in figure 2.
