Hydraulics & pneumatics

Keeping clean
in a dirty
environment

Clean fluid speaks volumes

Establishing and following a program to keep fluid clean saves time, money, and reduces downtime.

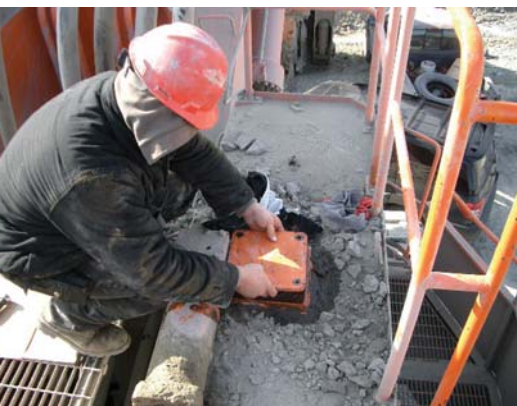
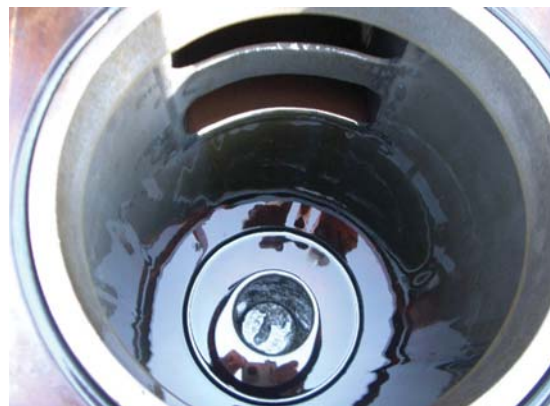
Action to reduce contamination of a Hitachi EX2500 excavator involved installing gaskets when none had been originally provided, left, and providing a flow deflector to protect filter elements from high-velocity oil, which were not provided in the original housing, right.

The housing inlet port was found to be causing damage to the pleated media, compromising the element's efficiency. A perforated flow deflector was added to the new element to protect it from damage in service. Inspection of spent elements revealed signs of abrasion and that the original elements were not sealing properly with the housing, so gasket seals were added. The original element had no seals to prevent fluid bypass.

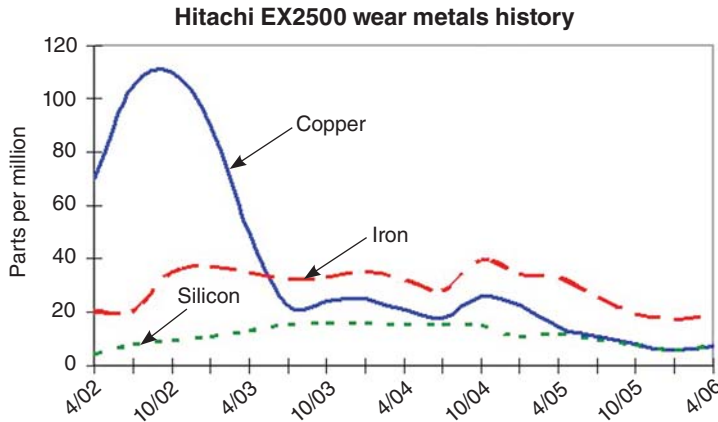
This graph verifies how a total system approach to cleanliness reduced component wear over a four year period.

The result — The impact of the fluid change was seen almost immediately. Copper levels, indicative of pump shoe wear, dropped by an average of 70%, and overall component wear metals also dropped. The fluid service life was extended to 17,000 hr, far exceeding the OEM rated fluid service of 4000 hrs. The 12-µm flushing element was replaced after 50 hrs of service, then the 6-µm element was installed. The result is better than the target cleanliness of 15/12/9.

Overall hydraulic fluid cleanliness levels have greatly improved by reducing contamination ingress and removing more contaminants through filtration. The substantial costs associated with component wear have also been drastically reduced over the past four years. This resulted in the elimination of four pump replacements, 39 hr of shovel downtime, and a 400% increase in hydraulic fluid life.
